An 18c. 5 bay barn, possibly axled on one side with a corresponding lean-to with cat-slide roof on the other. The roof is hipped and tiled, the walls weatherboarded on an ironstone plinth.

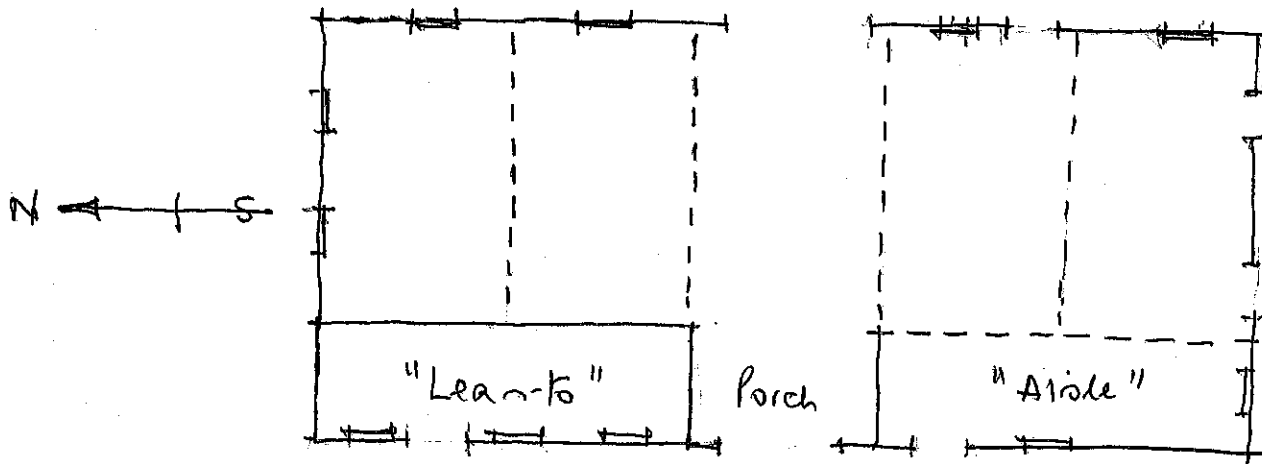
Apparently all one build, but with some re-used timbers. Roof originally had clasped purlins, Queen posts and collars. Posts & braces have chiselled carpenter's marks, tie beams have scratched carpenter's marks. Braces straight, as are short down braces in walls. All joints pegged. Roof new with ridge board. The "aisle" appears to be original, with its own rafters and large straight braces up to wall plate. One post has 1783 roughly carved on it. Two South bays floored over.

Porch weatherboarded on brick plinth. "Lean-to" has ironstone plinth. Many alterations to barn.
