A 4 bay medieval open hall house with jettied, floored East end. Timber framed with arching braces, brick nogged, clasped purlins, hipped roof, the West end rebuilt in brick. Probably a farm house, divided in two later. c. 1550

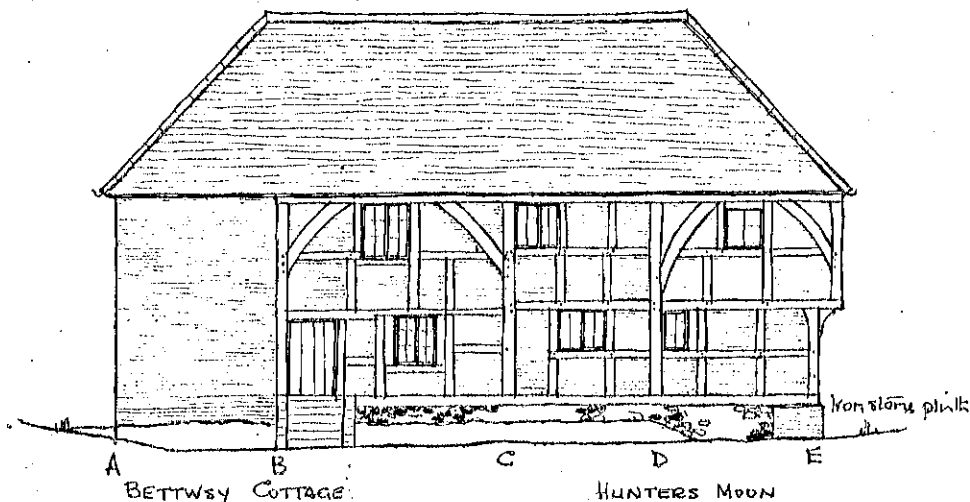
Jettied to farm yard. Long arching braces. Flat stepped steps to wall plates. Shutter groove to E. end for floor widows. Jewls at E. E. is hold jetty. Two bays floored (at E. end) with one bay open hall is unusual - was the bay C+D open to the hall on the ground floor? This is known. Wide jewls. Curved wind braces. 1839 one house, now two.
