Summary by Caroline Martin - Albury History Society - alburyhistory.org.uk

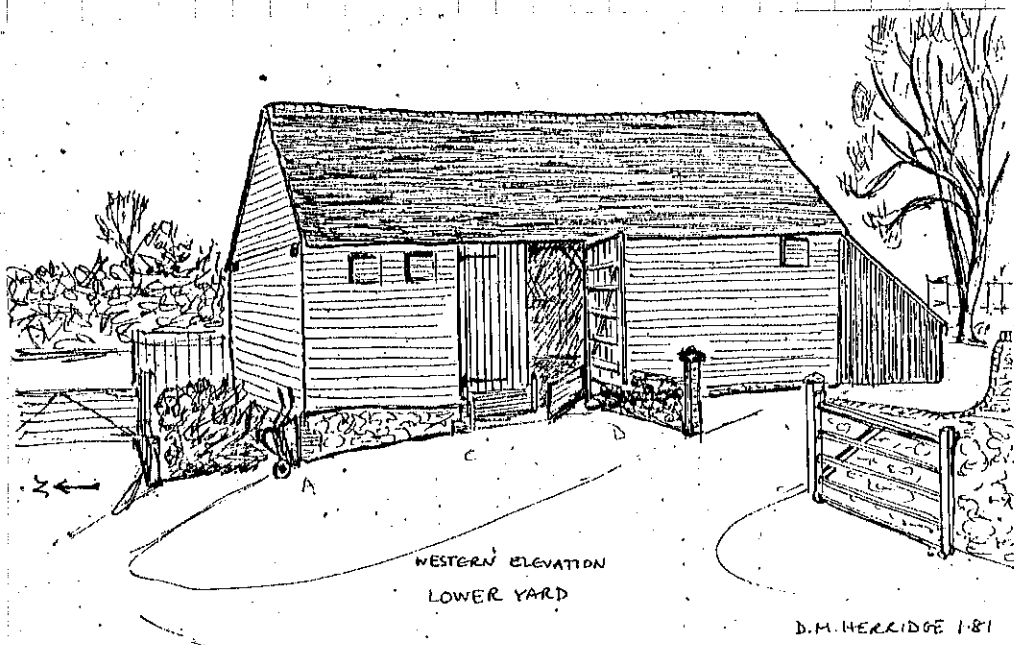
Probably 19c. 6 bay barn, on stone sill, high, with brick quoins. Weather boarded, sanded, tiled.

Roof has clasped purlins, vertical Green posts, collars and ridge board straight braces to ties, and in walls
